# Taking care of your sewer network

## Kinfauns Drive Sewer Repair Project

Welcome to this newsletter for our £2.5 million improvement project in Kinfauns Drive. We are taking care of the waste water services in your community by repairing the sewer network to help protect the environment.

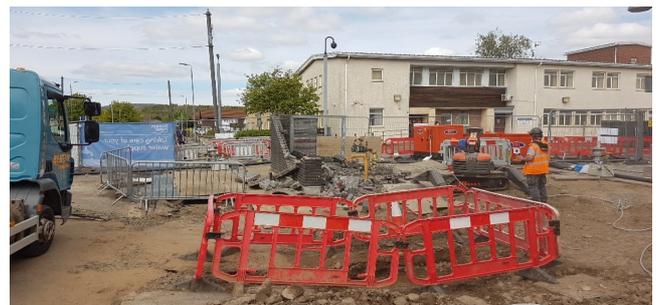
### Gas Meter House Demolition

Working with the NHS, we managed to keep Drumchapel Health Centre open while their gas supplies were diverted. The existing meter house was demolished as soon as the supplies were moved.

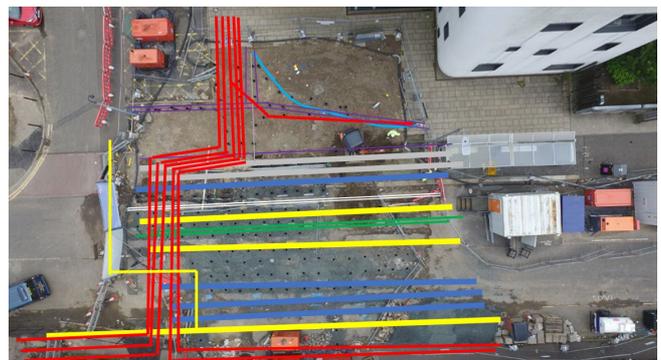
### Utility Location

From available records it was clear that there were numerous major utilities passing through the area. There were also numerous cables, pipe and ducts that were uncharted which had to be identified and traced throughout the site. In total, over 40 separate items of utility apparatus were discovered, many of which provide the main supplies of water, gas, power, broadband and TV to the Drumchapel area. Extreme caution was required to ensure these customer supplies were not interrupted.

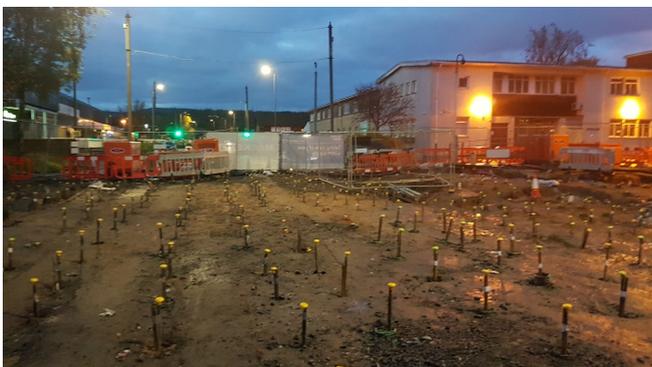
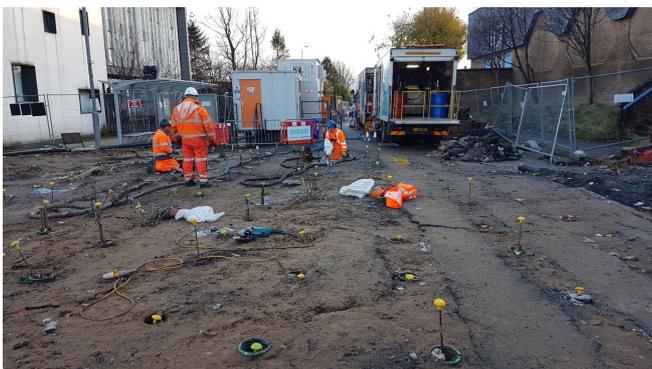
### Ground Stabilisation

Many options were considered but only one was deemed to be feasible. The method, known as compaction grouting, was selected as this was thought to have the highest chance of success in the shortest timeframe. This involved drilling over 1500 holes into the ground at various depths to inject a geopolymer resin into the soil. This foam like material expanded and compacted the soil between the injection points making it stronger and able to carry the necessary loads.
